# *Operation* **UPSHOT-KNOTHOLE**

Project 21.2

**EFFECTS OF AN ATOMIC EXPLOSION ON TWO TYPICAL  
TWO-STORY-AND-BASEMENT WOOD-FRAME HOUSES**

Federal Civil Defense Administration  
Washington, D. C.  
September 1953

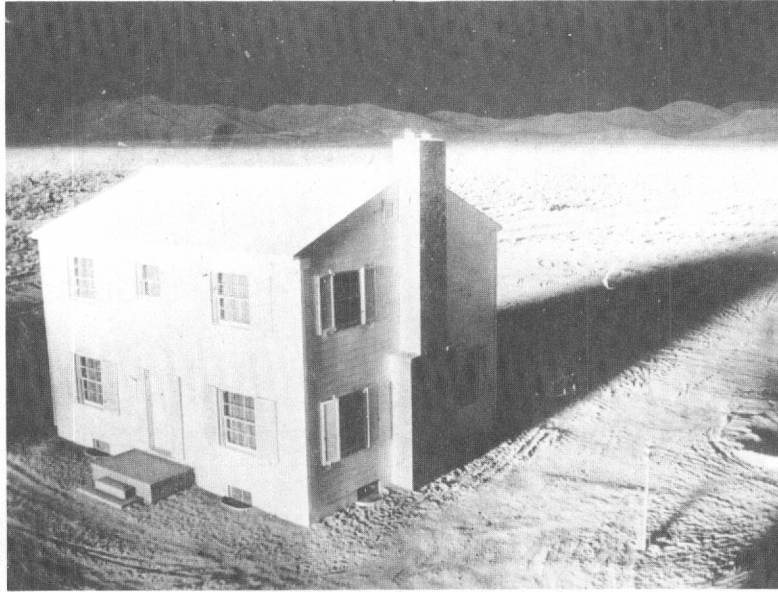
**Fig. 1.1—House at 3500 ft, zero time, instant of detonation. The blinding light from the detonation throws the house, the desert, and the surrounding hills into sharp relief.**

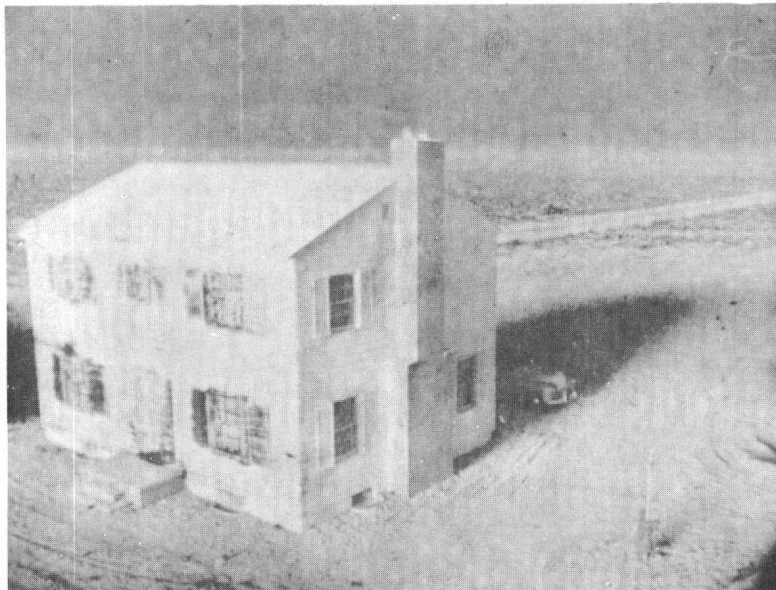
**Fig. 1.2—House at 3500 ft,  $\frac{5}{24}$  sec after detonation. The charring deepens around the windows and doors; the wood base of the floodlight pole (lower right) is smoking.**

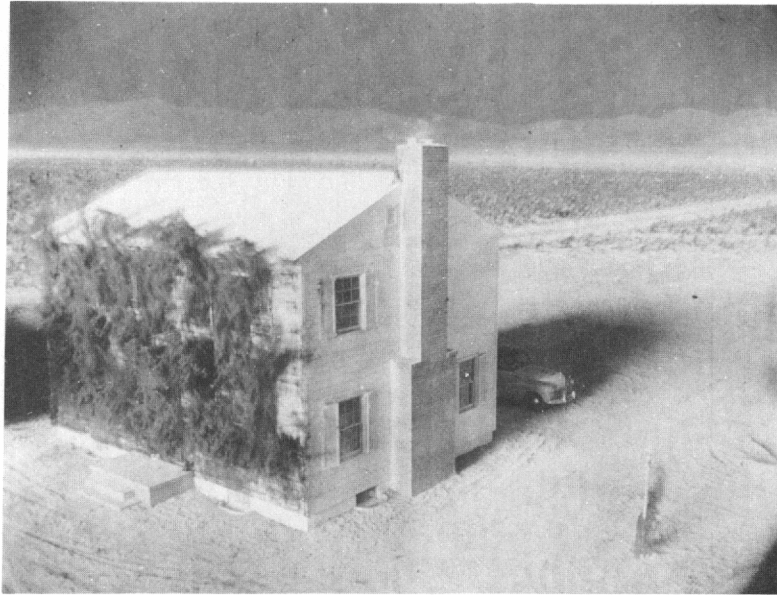
Fig. 1.3—House at 3500 ft,  $1\frac{15}{24}$  sec after detonation. The front of the house is almost obscured by smoke.

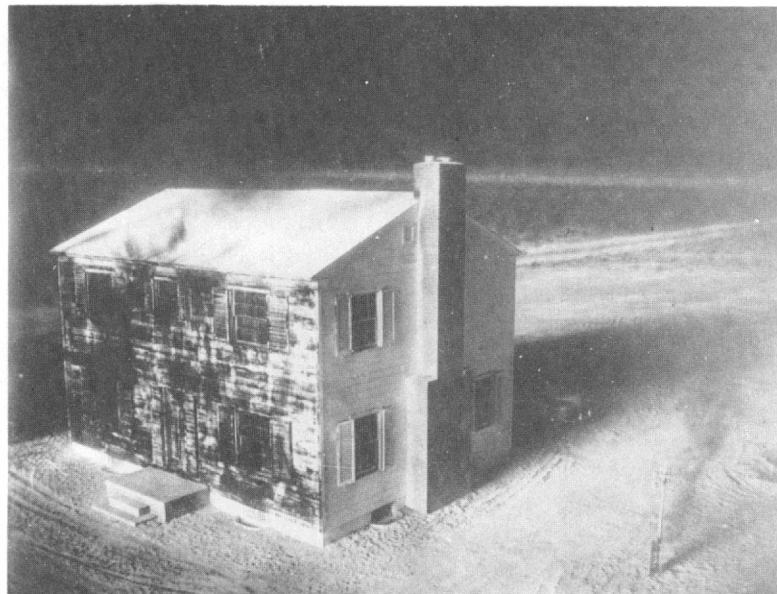
Fig. 1.4—House at 3500 ft,  $1\frac{15}{24}$  sec after detonation. The smoke is virtually gone.

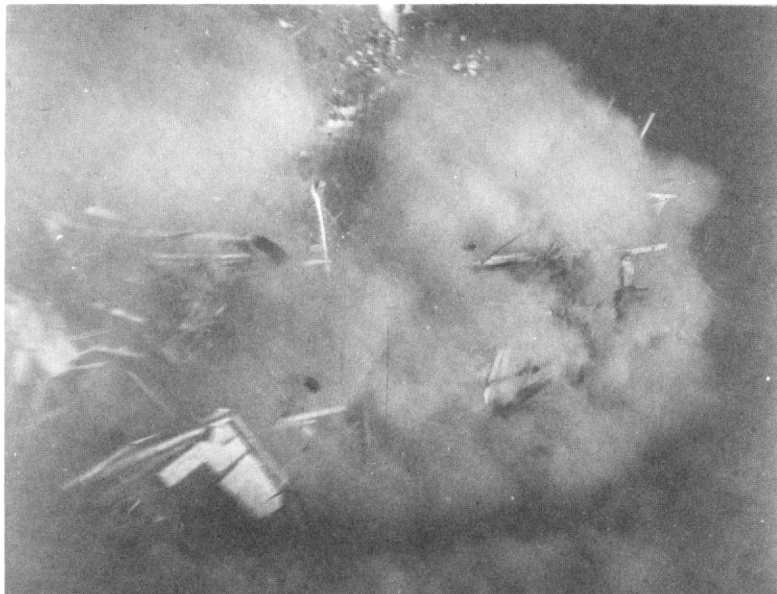
Fig. 1.8—House at 3500 ft,  $2\frac{2}{3}$  sec after detonation. This once was a house.

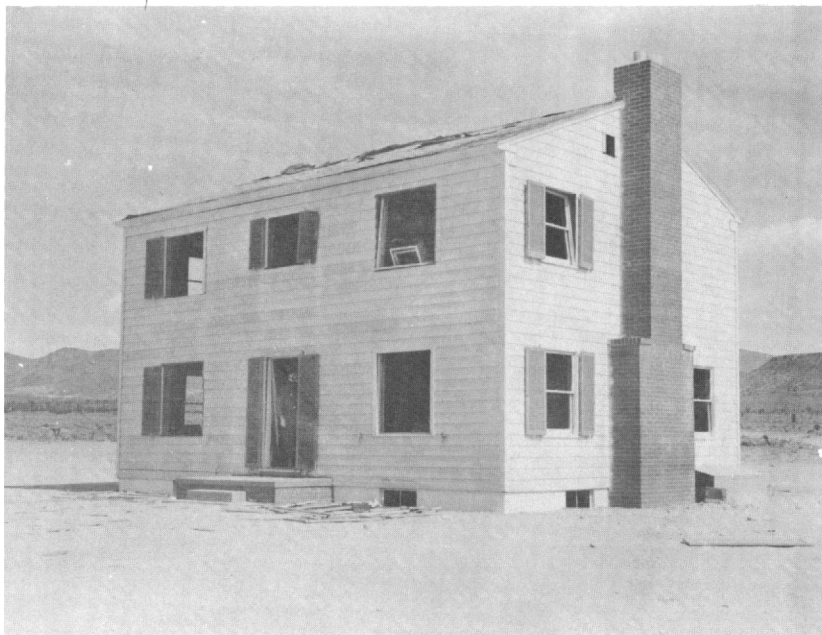
**Fig. 2.2—House at 7500 ft after the blast.**

Figures 2.1 and 2.2 show the far-range house before and after the blast. Figures 2.3 to 2.6 show blast damage from the outside on sides and rear of the house. Doors, windows, and window frames in general either were blasted out of the walls or remained in place in badly damaged condition. The glass in the windows was shattered into small particles and scattered uniformly about the interior of the house. The exceptions to the general rule were four windows in the rear of the house, which had been sheltered by partitions from the blast that entered through the front and side openings, and the basement windows in the rear of the house, which were blown open inward.

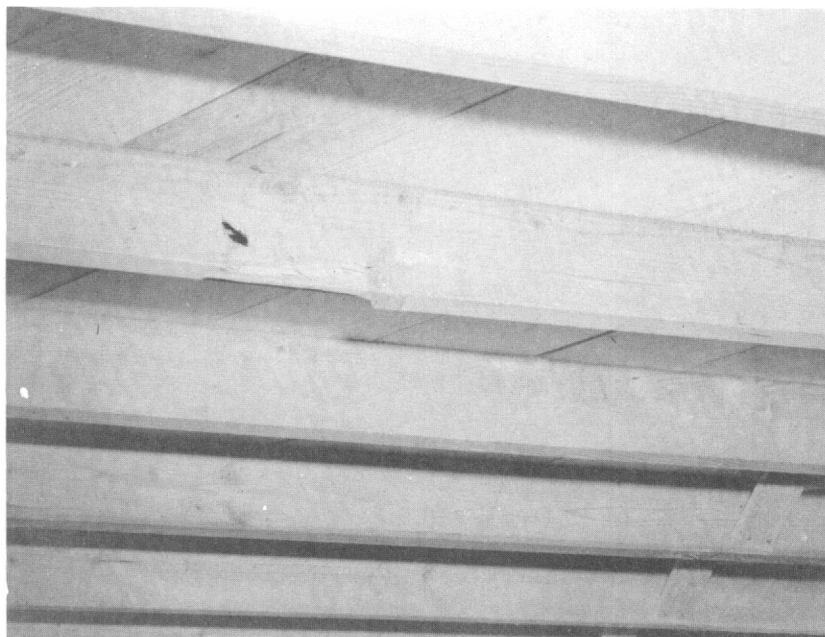
The basement was relatively free of debris except for that from the outside entrance doorway and suffered minor damage as shown in Figs. 2.7 and 2.8. The 6- by 8-in. wood girders, pipe columns, and most of the 2- by 8-in. floor joists of the first-floor system were undamaged. Figure 2.9 shows a split joist at about the third point under the kitchen. Figure 2.10 shows, under the dining room, the fourth joist from the front broken at a 4-in. knot, the fifth joist split, and the sixth broken at a 3-in. knot. Figures 2.11 and 2.12 show two views of the floor-joist damage under the living room. The joists framing into the double header were designed to be supported by steel joist hangers but were only spiked to the headers. These nails bent, allowing the supported joists to drop about 3 in. at the support, splitting one joist and pulling out the nails that secured the subflooring to the joists. The trimmers were shown on the architectural drawings as being doubled, but in the construction they were single joists and failed in horizontal shear in one and in bending in the other. Figure 2.11 also shows two other floor joists under the living room which failed in bending at approximately midspan.

**Fig. 2.9—Floor joists under the kitchen.**

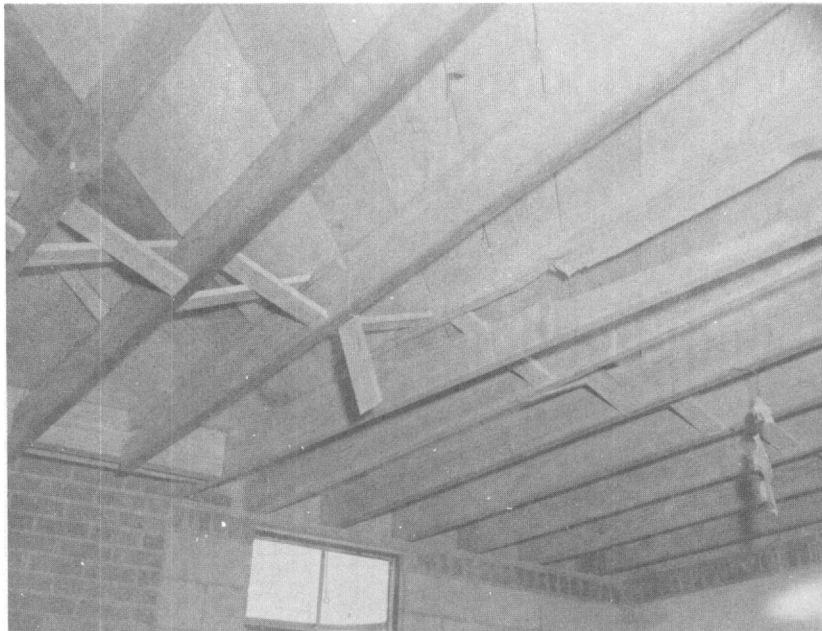
**Fig. 2.12—Rear floor joists under the living room.**

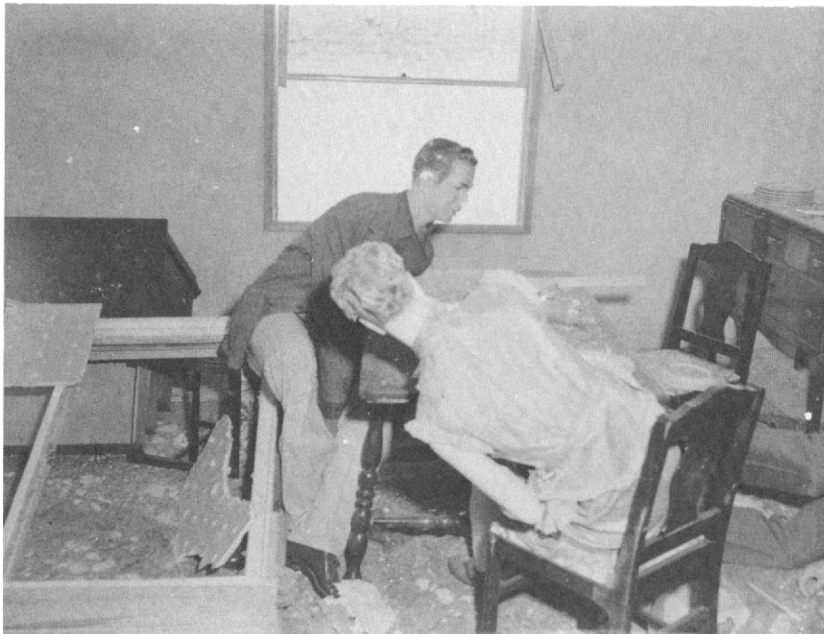
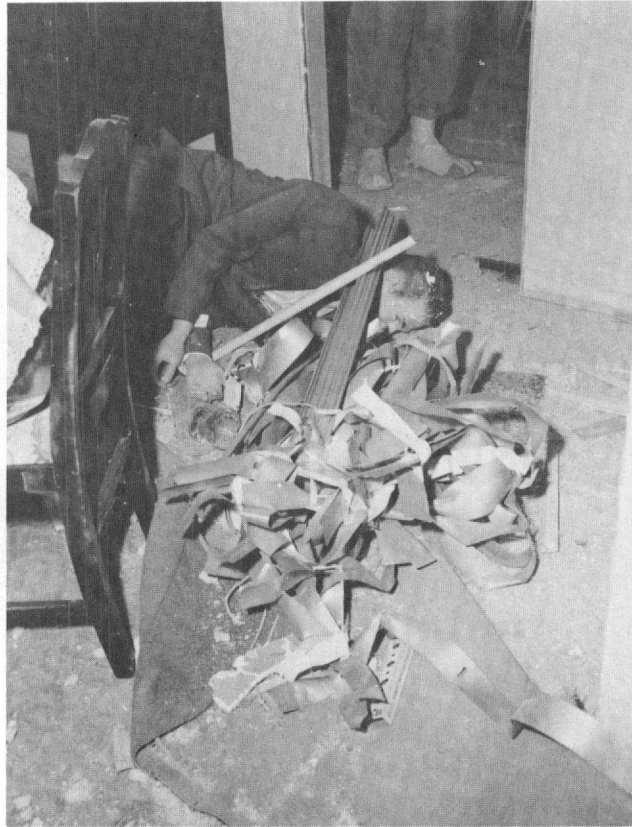
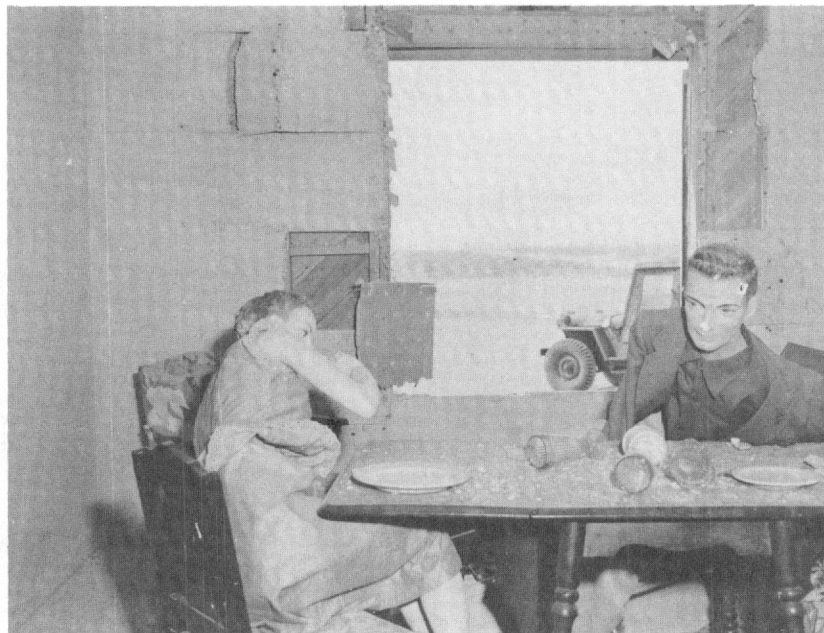
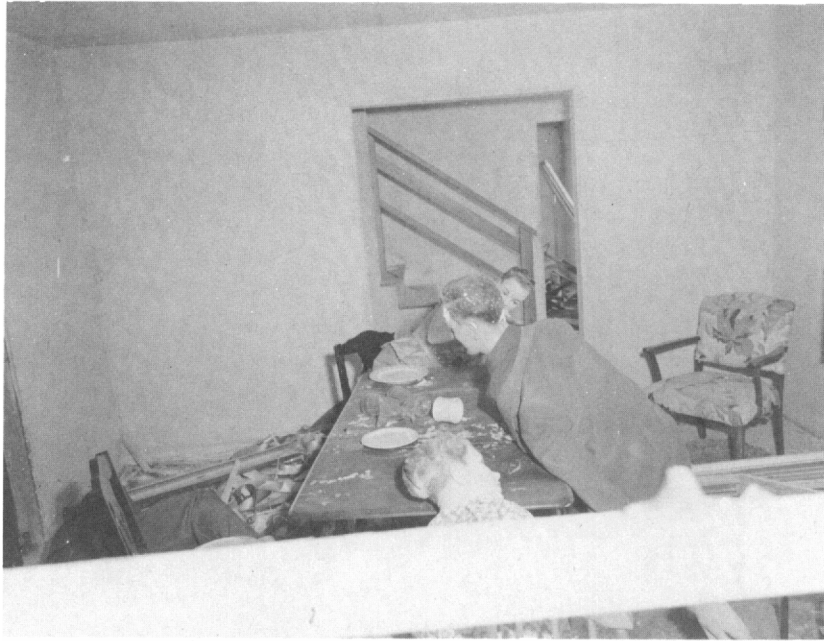
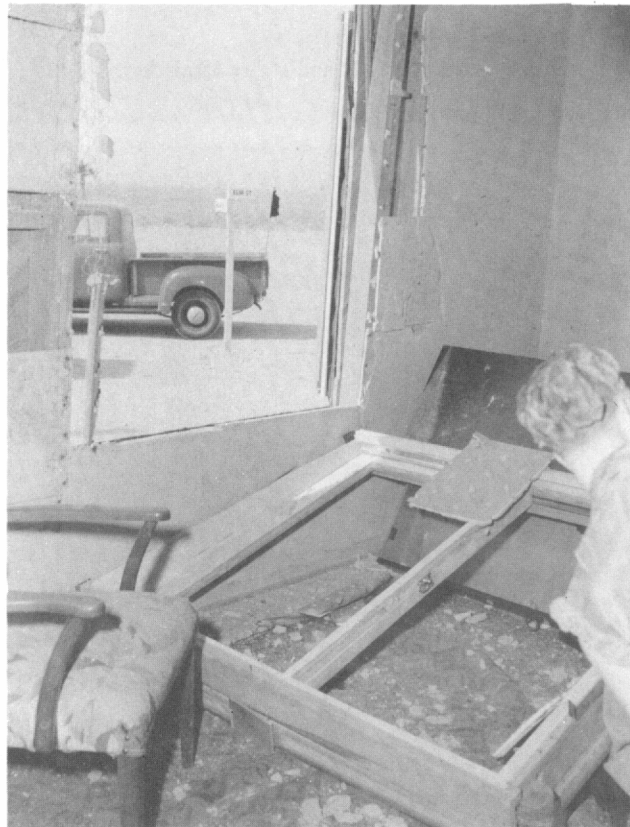
Figure 2.13 is a view of the dining room before the explosion; the front facing the blast is to the left in the figure. Figures 2.14 to 2.18 show the damage to and the positions of department-store mannequins in the dining room after the blast.

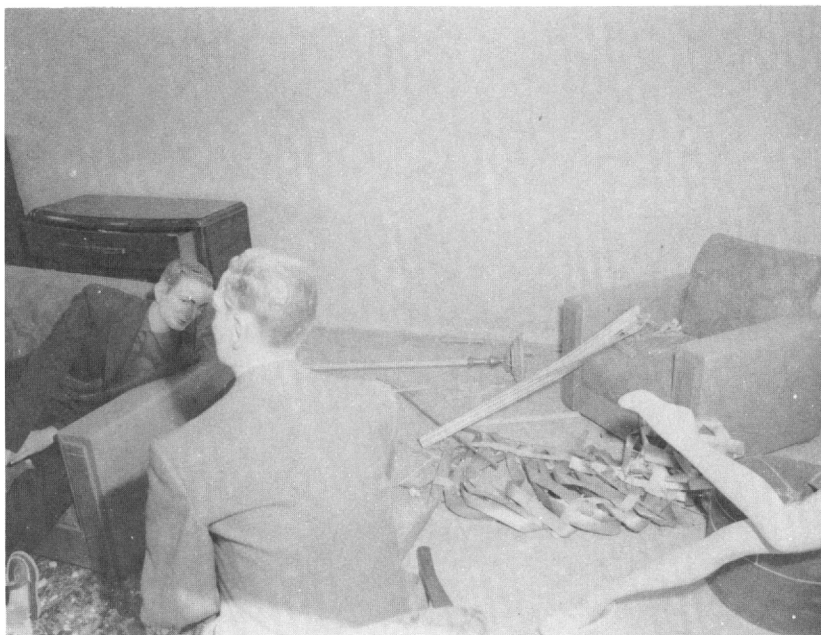
Figure 2.20 shows the living room before the blast; Fig. 2.21 shows a similar view of the living room after the blast. The child mannequin was found undamaged under the fireplace screen after the explosion but was removed before this photograph was taken. Figure 2.22 shows the rear end of the living room with the Venetian blind from the front window having been blown by the blast about 20 ft from its original position. Extensive damage to plaster and one broken first-story stud are shown in Fig. 2.23, which is a view of the front entrance taken from the living room. Plaster cracks around the fireplace indicated that there had been some deflection inward of the first-story studs in this side of the house.

**Fig. 2.22—Rear end of the living room after the blast.**

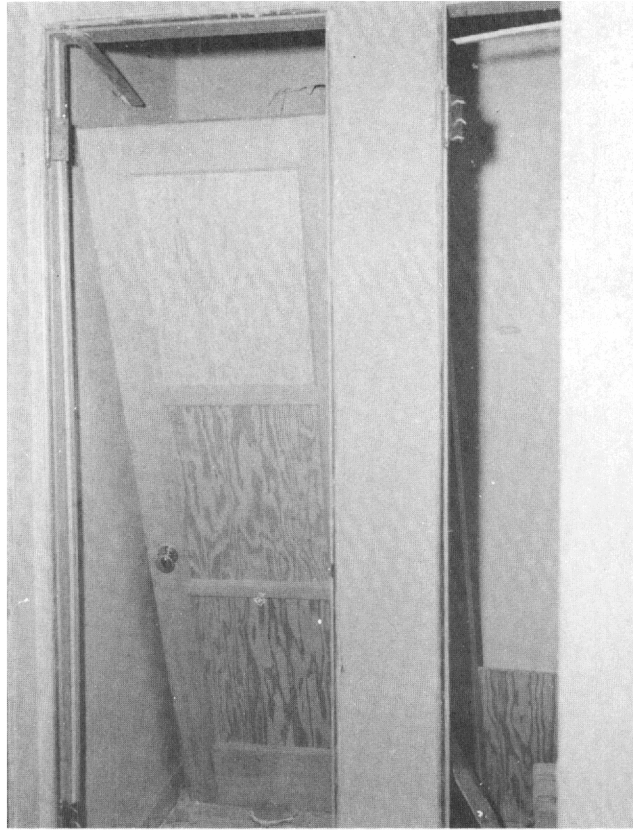
Figure 2.27 shows the door to the first-floor coat closet ripped off its hinges, turned 180°, and wedged in this position. It also shows the opening to the basement stairs minus the door.

**Fig. 2.27—Coat closet after the blast.**

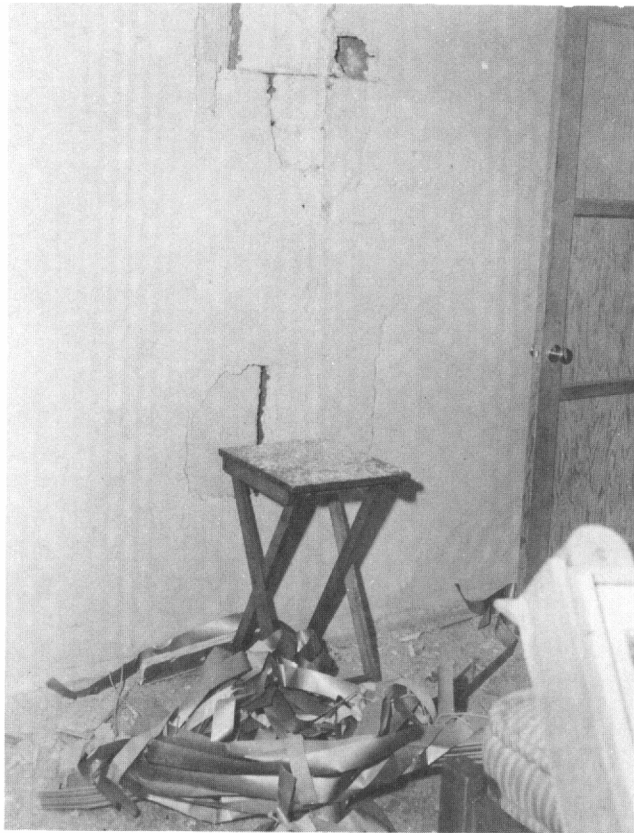
Figure 2.30 shows the front bedroom. To the left is shown one broken second-story stud, but from the horizontal plaster crack it is probable that the other studs split also. Plaster damage to the back wall of the front bedroom is shown in Fig. 2.31. The door to this room was open at the time of the explosion.

**Fig. 2.31—Front-bedroom plaster damage.**

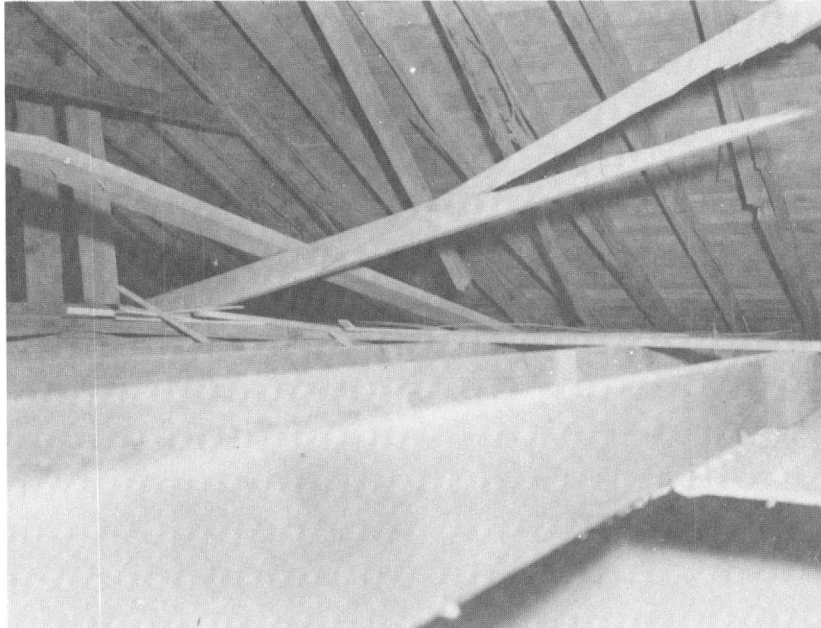
Figure 2.33 is a view of the front roof rafters taken through the hole in the master-bedroom ceiling. Only one broken roof rafter is visible. However, all roof rafters on the front of the house with the exception of one near the gable end were broken at approximately midspan (see Fig. 2.34). A photograph (Fig. 2.35) taken through a hole in the rear-bedroom ceiling shows the ridge board, which was carried down by the broken rafters in the front of the house, and the rear roof rafters that suffered no damage. Figure 2.36 shows damage to the south closet in the master bedroom and the Venetian blind from the front window of this room.

**Fig. 2.34—Damage to the roof, front of house at 7500 ft.**

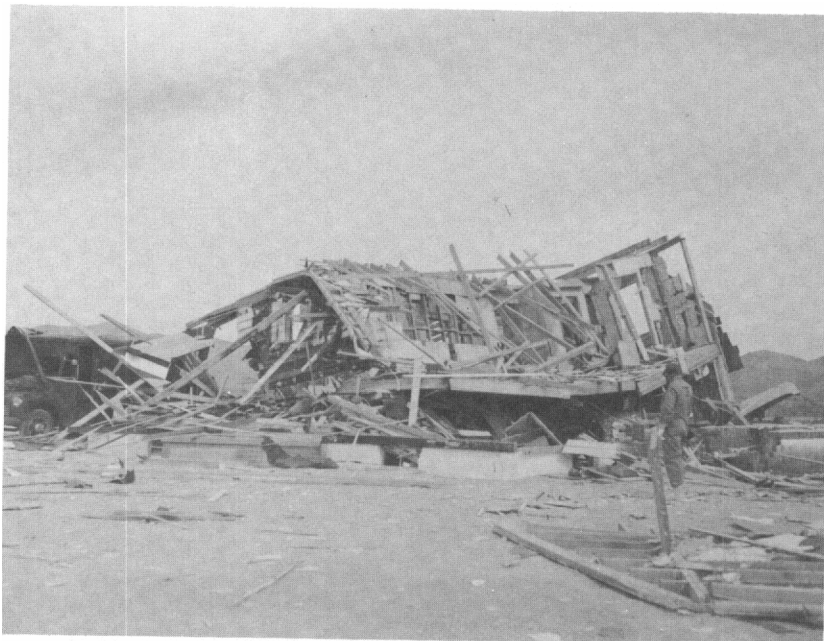
Figure 2.37 shows the front (facing the blast) of the near-range house before the explosion. Figure 2.38 shows a general view of the house after the blast, taken from about the same point. Moving around the house from the front counterclockwise, the damage is shown on the other three faces in Figs. 2.39 to 2.41. In the foreground of Fig. 2.41 the floor of the kitchen entrance is shown in an upside-down position. The house was demolished beyond repair.

**Fig. 2.38—House at 3500 ft after the blast.**

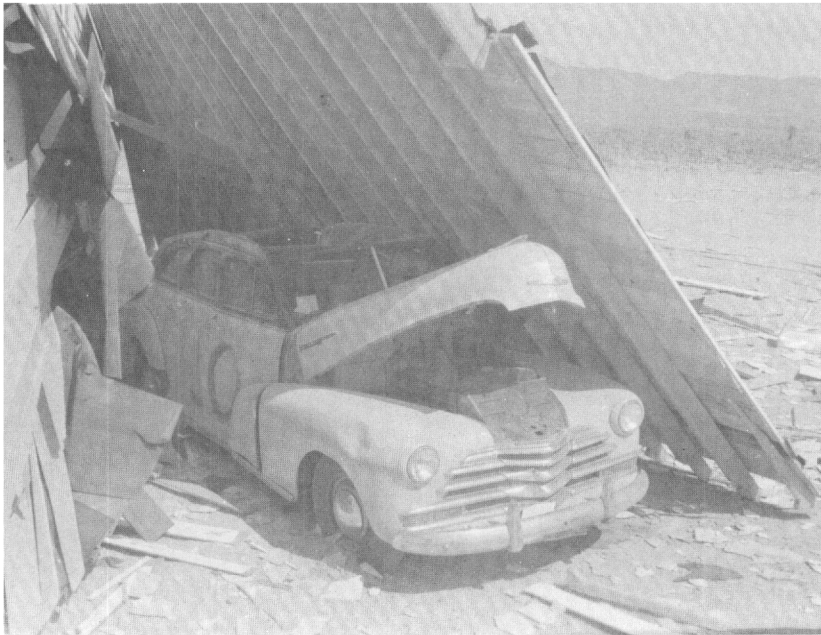
Figure 2.42 shows the large area over which debris was scattered. The front half of the roof broke in the middle at approximately the midspan of the rafters, the lower part lifting at the eaves, as shown by motion pictures, pivoting about the break, and sailing through the air to land on the ground in the rear of the house (see Fig. 2.43). The upper part of this broken roof was found upside down on the ground in front of the house, as shown in Fig. 2.44. The rear half of the roof slid off the house to the rear over a test automobile shown in Fig. 2.45. This section was later laid on the ground at the back of the house and can be seen in Fig. 2.43.

**Fig. 2.45—Rear section of the roof.**

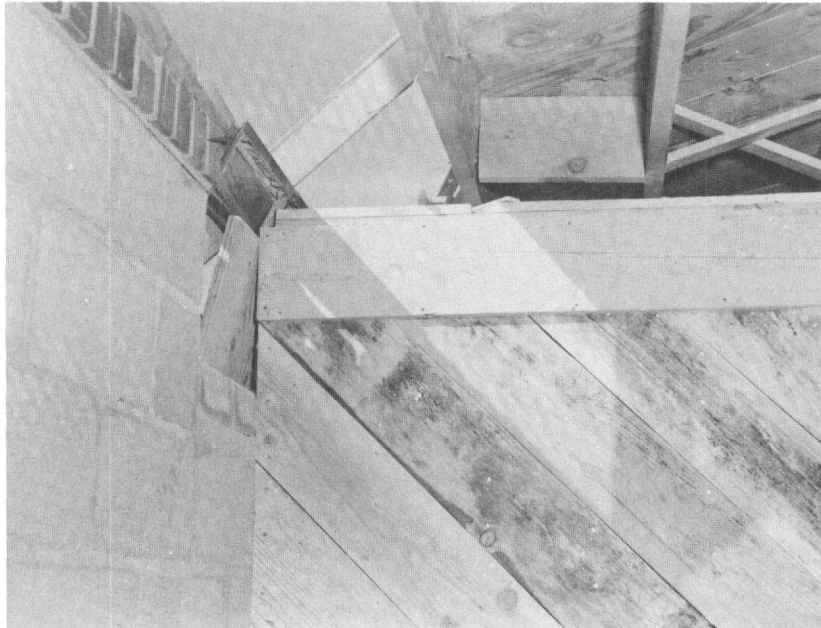
The first-story stud walls were disintegrated by the blast and allowed the second story to drop on the first floor. Most of the living-room floor sagged into the basement due to broken joists. The first-floor framing system moved, in general, as a unit toward the rear of the house, about 2 ft at the right side (looking at the front of the house) and 1 ft at the left (see Fig. 2.46 which shows the distance that the first floor moved at the basement corner-room shelter). The ends of the 6- by 8-in. wood girders were pushed through the masonry foundation wall at the rear of the house, as shown in Figs. 2.47 and 2.48. The ends of the wood girders at the front of the house moved off their bearings (Fig. 2.49) a maximum distance of 1 ft 3 in., and the girders cantilevered from the front pair of pipe columns. Base and cap plates of the pipe columns leaned to the rear but did not overturn.

**Fig. 2.46—Displacement of the first floor over the corner-room shelter.**

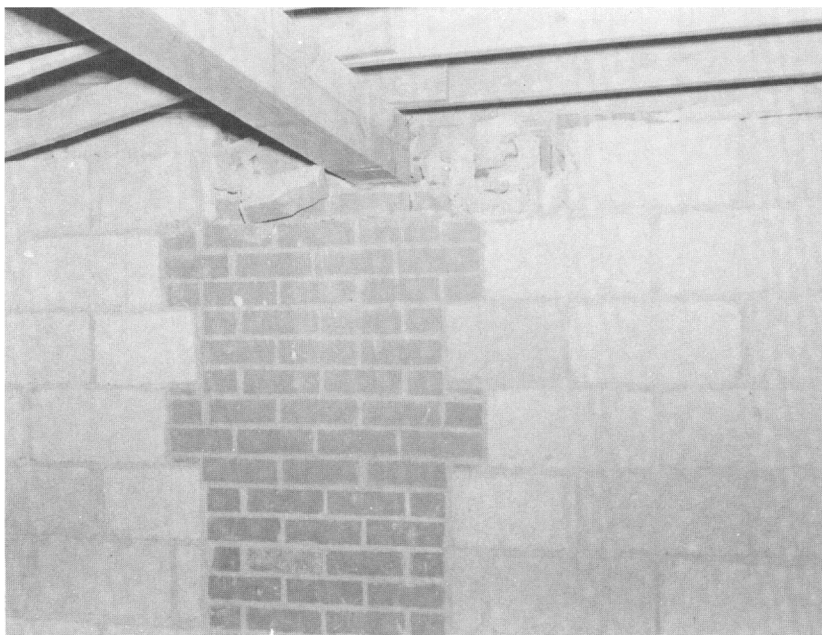
**Fig. 2.47—Rear wall punctured by a wood girder.**

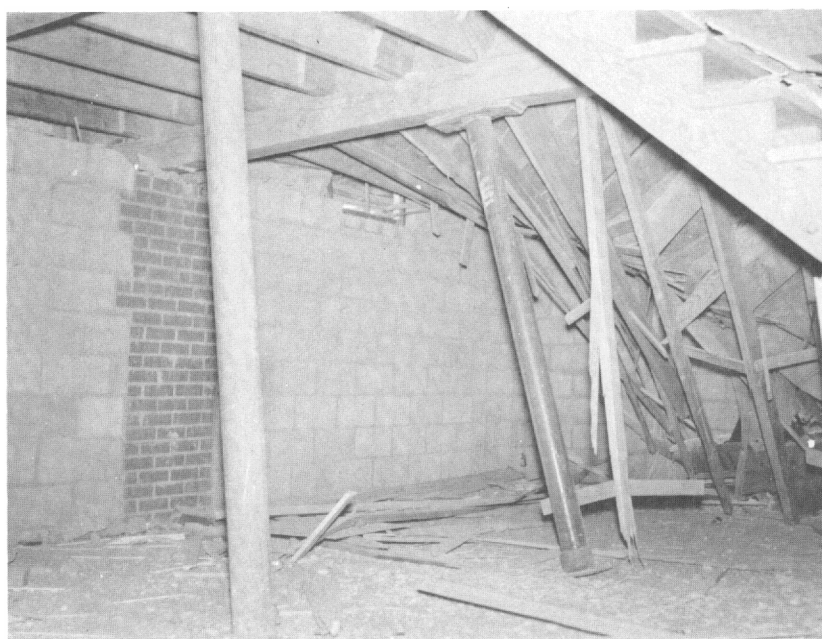
**Fig. 2.48—Basement, showing damage to the living-room floor.**

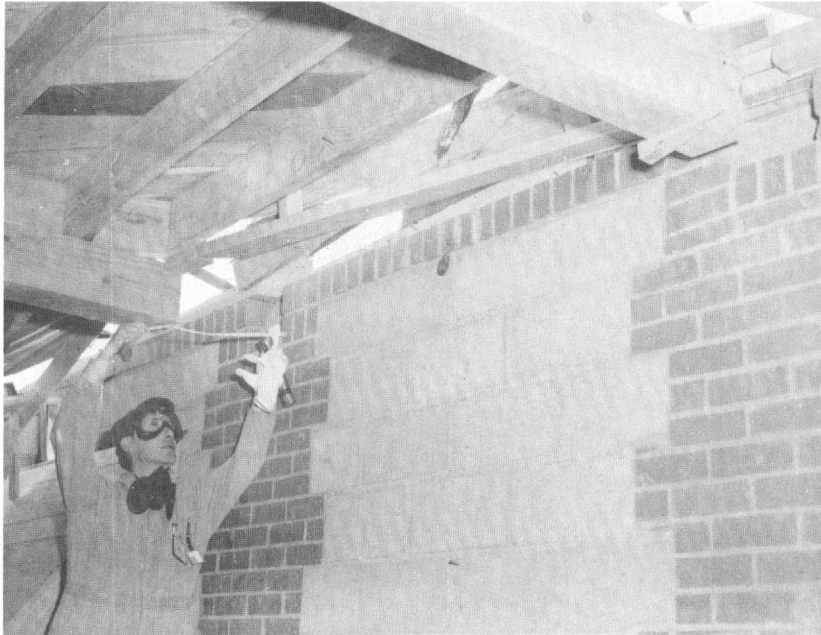
**Fig. 2.49—Front ends of the wood girders.**

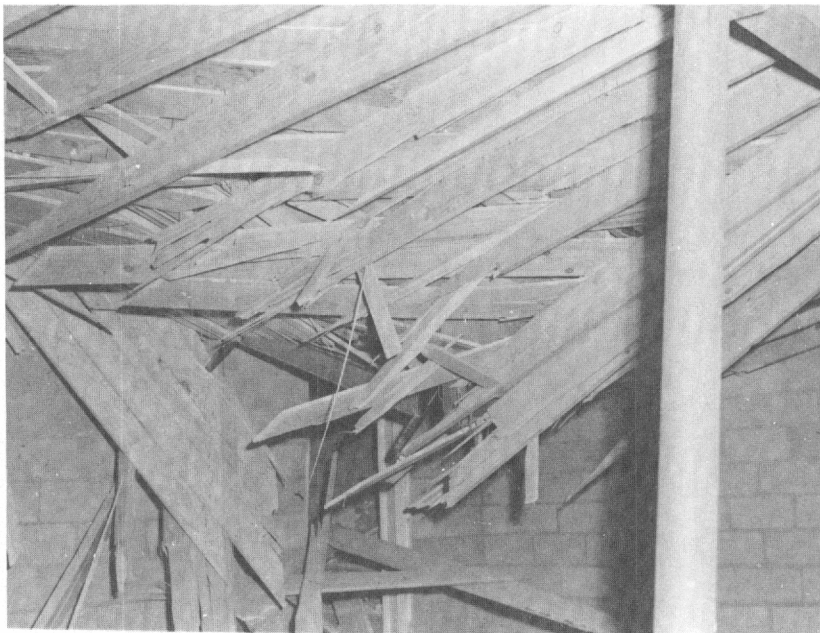
The kitchen-floor joists and those under the dining room, which were not supported by the basement corner-room shelter, broke and projected into the basement (see Figs. 2.50 and 2.51).

**Fig. 2.50—Damage to the kitchen and dining-room floors, toward the basement door.**

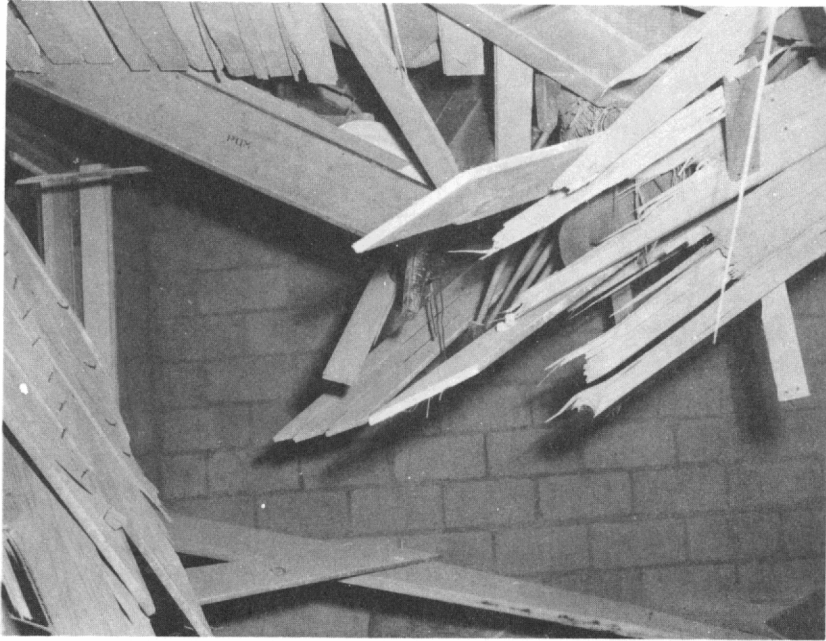
**Fig. 2.51—Damage to the kitchen and dining-room floors.**

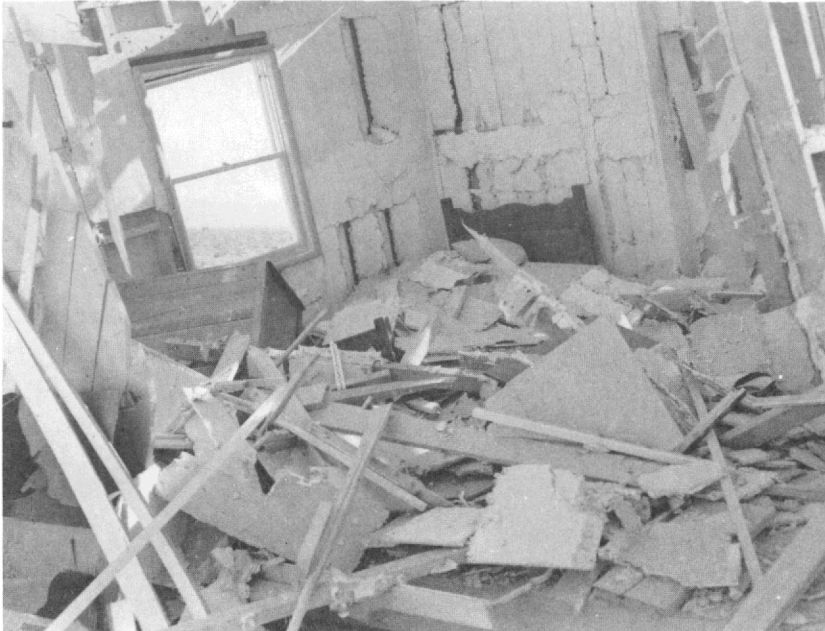
**Fig. 2.56—Damage to the second-floor rear bedroom.**

Figure 2.56 shows a distinguishable second-floor rear bedroom which fell on top of the kitchen.
